Manhole Inspection Summary

Manhole # S69M__030MH

Insp Date: **6/6/08 10:45 AM**

Location Address: **1209 Dundalk Ave.**

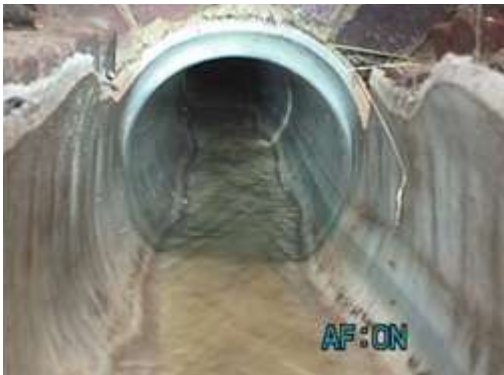
Defect 2

cracked pipe seal 11:00-1:00 outgoing 12 o'clock

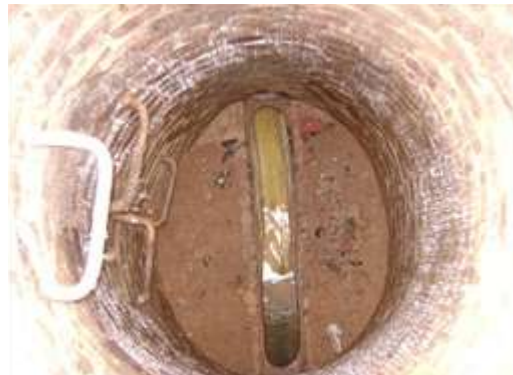
Defect 1

Condition: ☐ Sound ☐ Cracked ☐ Root Intrusion ☐ Loose Brick ☒ **Deteriorated**

Infiltration: ☐ None ☐ Joint ☐ Cracks ☒ **Mortar** ☐ Roots ☒ **Wall**

Condition: ☐ Sound ☐ Cracked ☐ Root Intrusion ☐ Deteriorated ☐ Leaks ☒ **Debris**

debris on bench from barrel wall infiltration

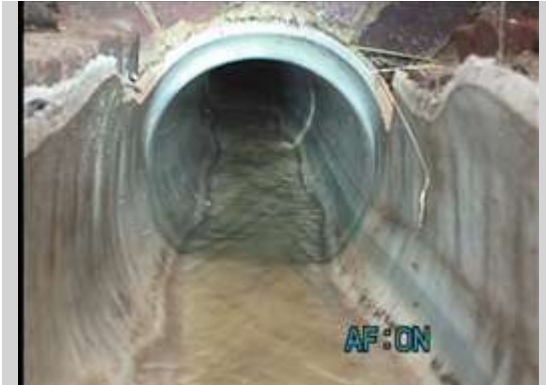
12 O'Clock Outflow

8 in. Circular Gravity Sewer
Pipe Out @ 12 O'Clock

Pipe Height: **8.4** (in.) Rod and Bar (Angled)
Pipe Material: **Clay** ☐ Pipe Lined
Invert Depth: **8.75** (ft.) Flow Characteristics: **Slow**
Deposits: ☐ None ☐ Mud ☐ Sludge ☐ Debris ☒ Grease
Silt Depth: **0.25** (in.) Deposits Extent: **Light**
Infiltration: **None** Pipe Seal Cond: **Cracked**

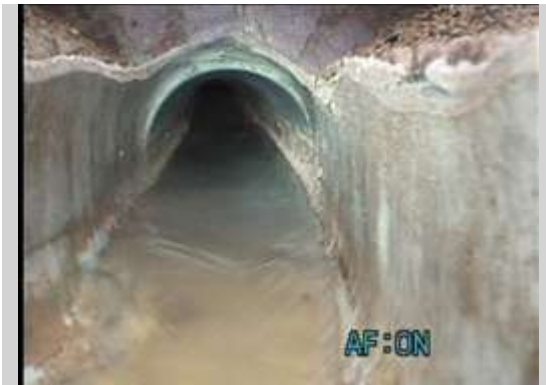
6 O'Clock Inflow

8 in. Circular Gravity Sewer
Pipe In @ 6 O'Clock

Pipe Height: **8.4** (in.) Rod and Bar (Angled)
Pipe Material: **Clay** ☐ Pipe Lined
Invert Depth: **8.67** (ft.) Flow Characteristics: **Slow**
Deposits: ☒ None ☐ Mud ☐ Sludge ☐ Debris ☐ Grease
Silt Depth: (in.) Deposits Extent:
Infiltration: **None** Pipe Seal Cond: **Sound**
